**UNITED STATES DEPARTMENT OF LABOR  
MINE SAFETY AND HEALTH ADMINISTRATION  
COAL MINE SAFETY AND HEALTH**

**REPORT OF INVESTIGATION**

**Fatal Underground Mine Explosion  
April 5, 2010**

**Upper Big Branch Mine-South, Performance Coal Company  
Montcoal, Raleigh County, West Virginia, ID No. 46-08436**

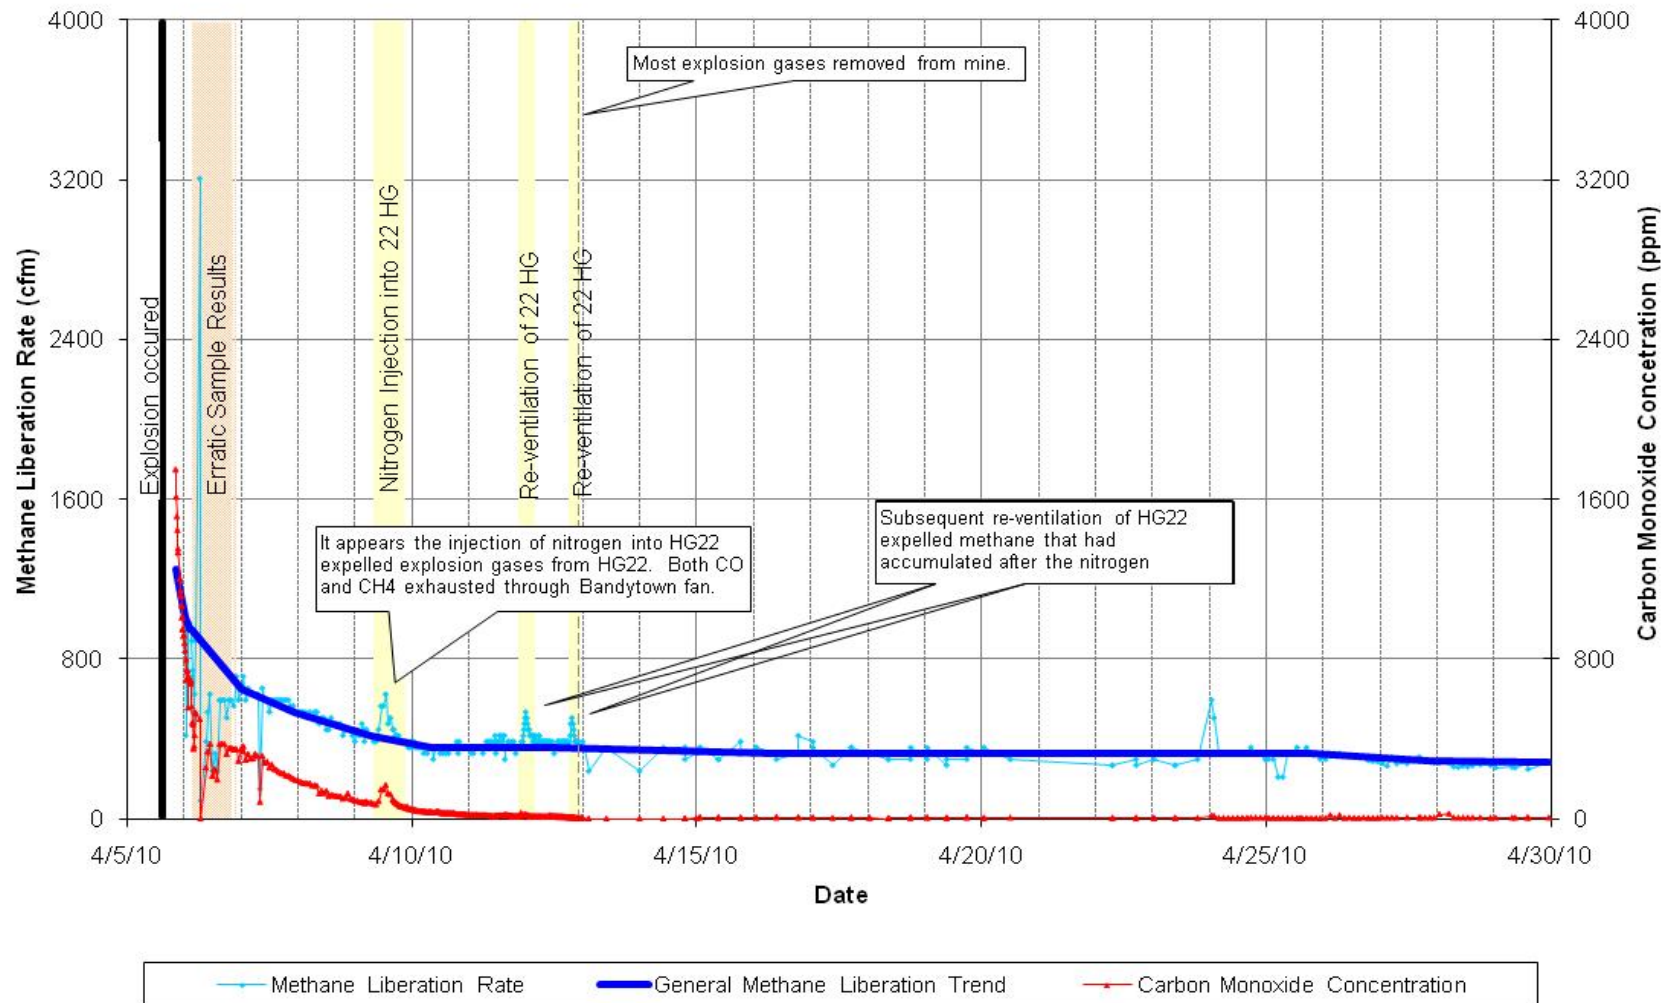
Figure 10: Methane Liberation Rate versus Carbon Monoxide Concentrations for Samples Collected from Bandytown fan from April 5 – 30, 2010

Beginning at 8:30 p.m. on April 5, 2010, air samples were collected regularly at the Bandytown fan for analysis using a gas chromatograph, which is not susceptible to the cross-sensitivity of gases. Figure 10 contains a graph depicting methane liberation rate versus carbon monoxide concentrations for samples collected from Bandytown fan from April 5 – 30, 2010. Sample results indicated that the total volume of methane that exited at the Bandytown fan at 8:30 p.m. was about 1,250 cfm. The methane liberation rate declined to 890 cfm by 5:00 a.m. on April 6, 2010.

A single sample, collected at 6:40 a.m. on April 6, 2010 and analyzed by the gas chromatograph, indicated an increase in methane, ethane and carbon dioxide while carbon monoxide, hydrogen, acetylene, and ethylene decreased slightly. Analysis of air samples collected after the explosion indicated normal declining trends. The apparent short-lived change in the concentrations of methane, ethane and carbon dioxide could not be explained conclusively.

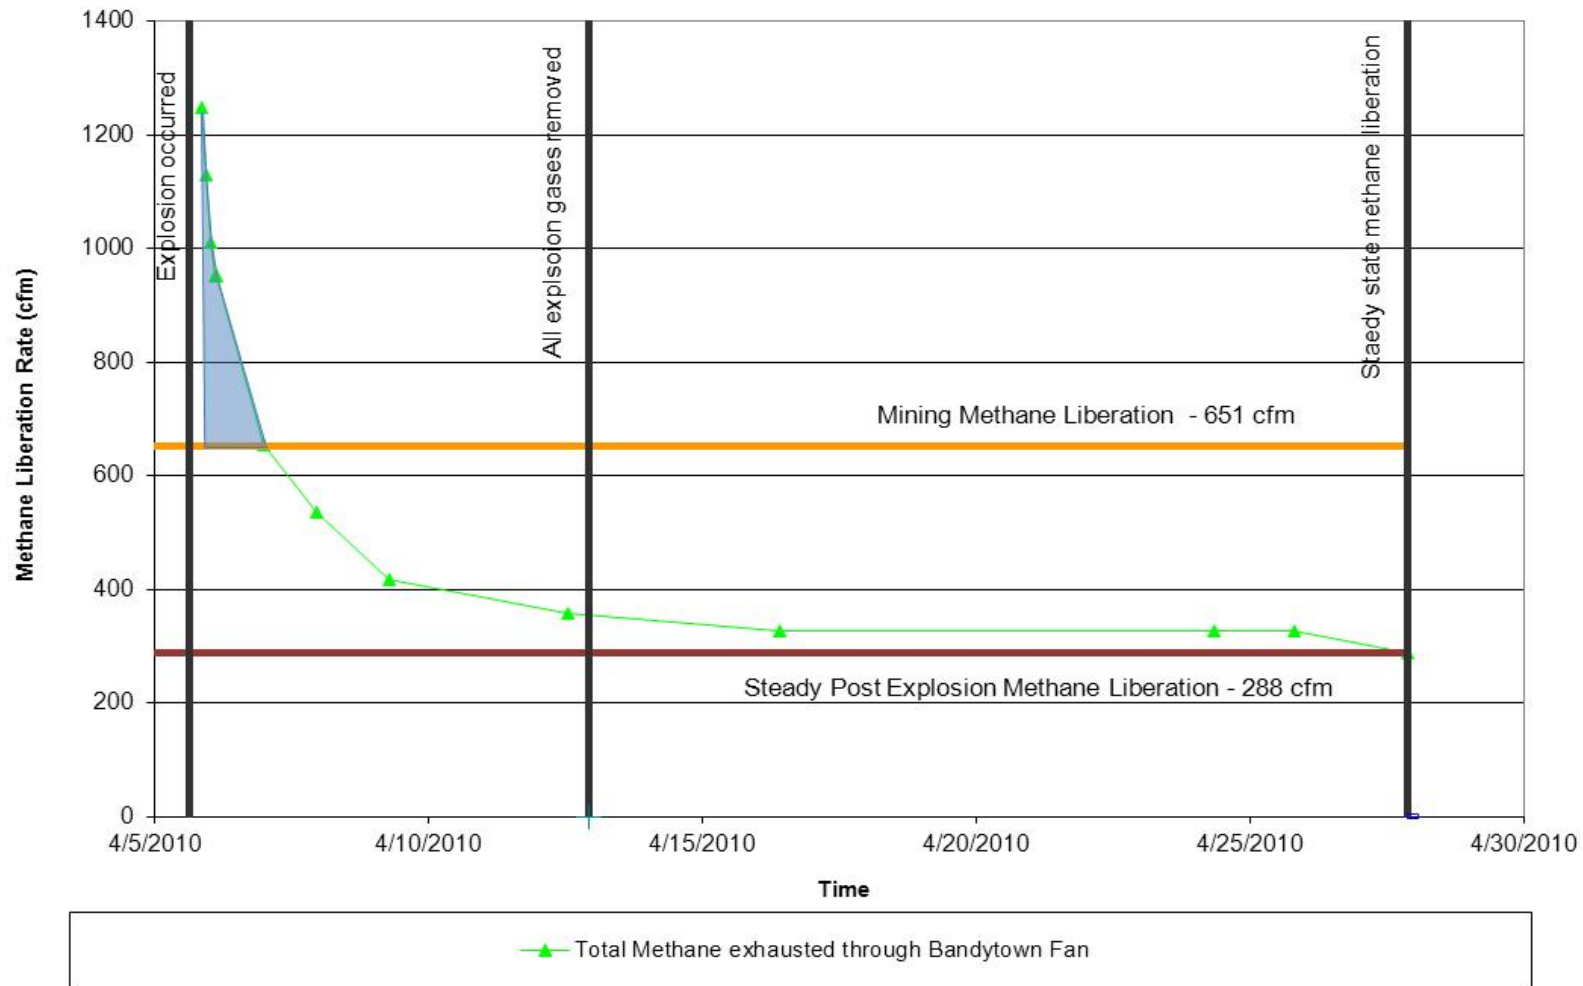
Figures 11 and 12 show graphical depictions of methane liberation rates from the Bandytown fan, based on information collected beginning 8:30 p.m. on April 5, 2010. The curve represents the total methane exhausted from the Bandytown fan from 8:30 p.m. on April 5, 2010 to April 30, 2010. The blue shaded area shown on Figure 11 represents the amount of methane exhausted as compared to the pre-explosion methane liberation. This represents the minimum amount of excess methane exiting Bandytown fan during the sampling period after the explosion. Figure 12 depicts the excess methane exhausted as compared to the post explosion steady-state methane liberation. This represents the maximum amount of methane exiting Bandytown fan during the sampling period after the explosion. Because the rate at which methane liberation from mining declines to the steady state non-mining rate is unknown, the actual amount of excess methane removed from the mine post-explosion would be between the two amounts shown on the graphs.

Figure 11. Graph of methane that was exhausted through the Bandytown fan for the period between April 5 and April 30, 2010. The area shaded in blue represents methane in excess of pre-explosion liberation levels.

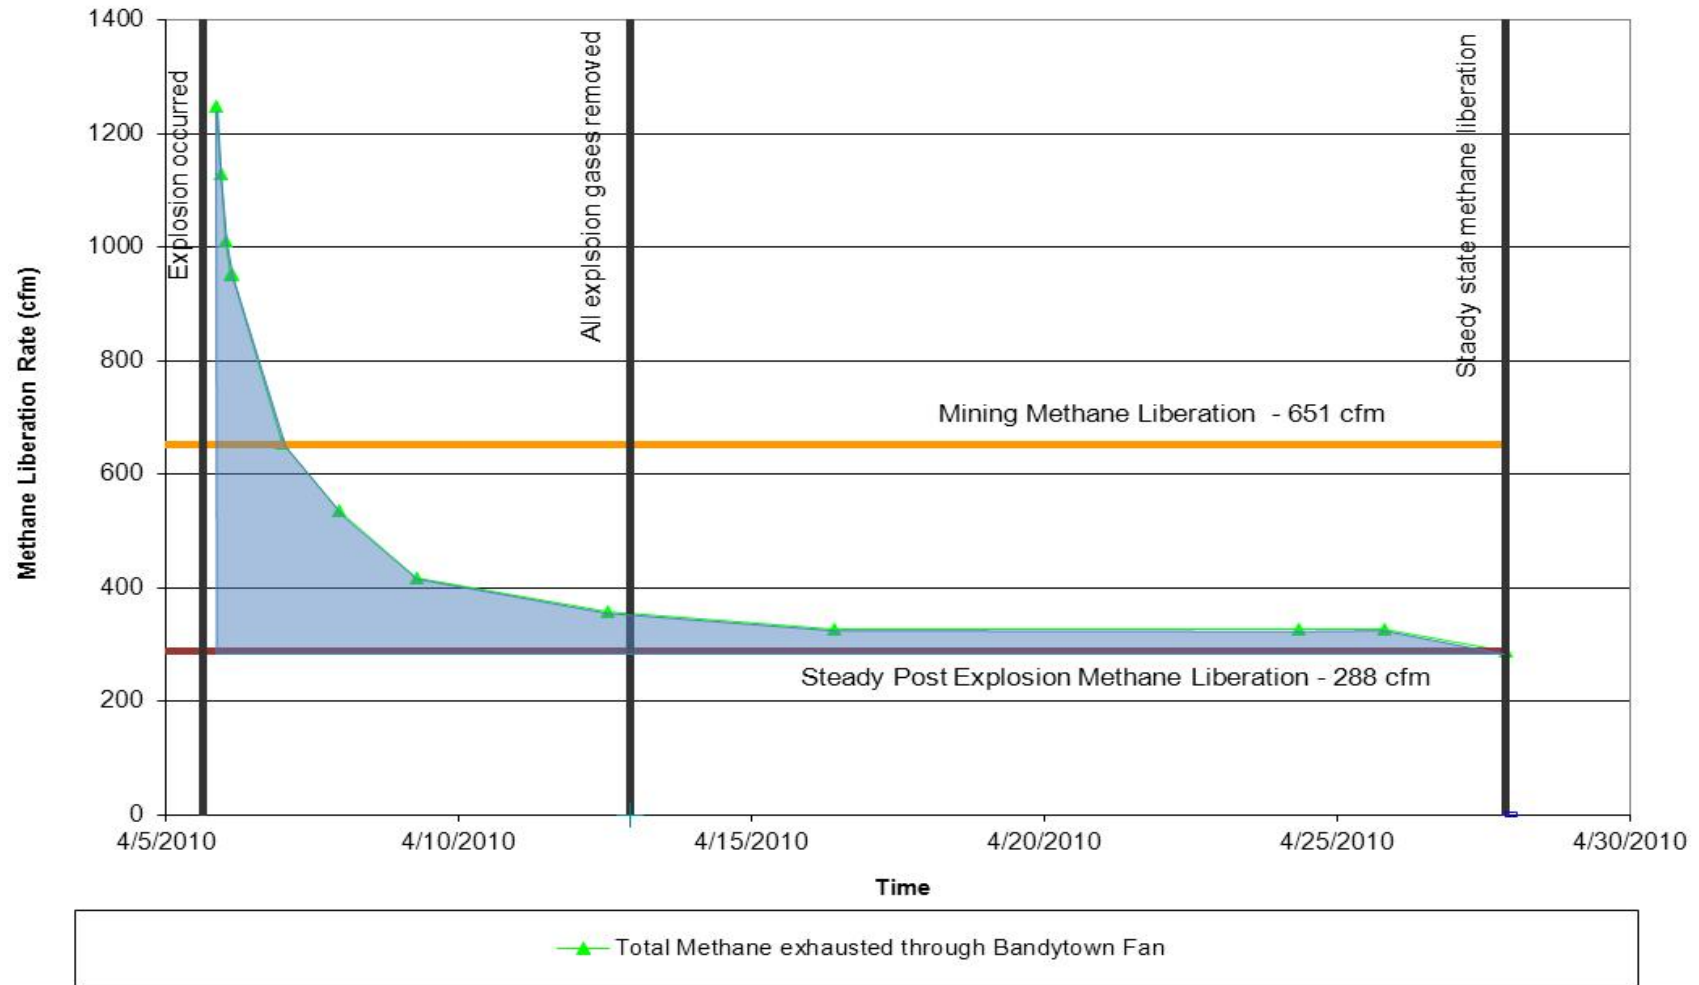
Figure 12. Graph of methane that was exhausted through the Bandytown fan for the period between April 5 and April 30, 2010. The area shaded in blue represents post-explosion methane versus steady state liberation levels.

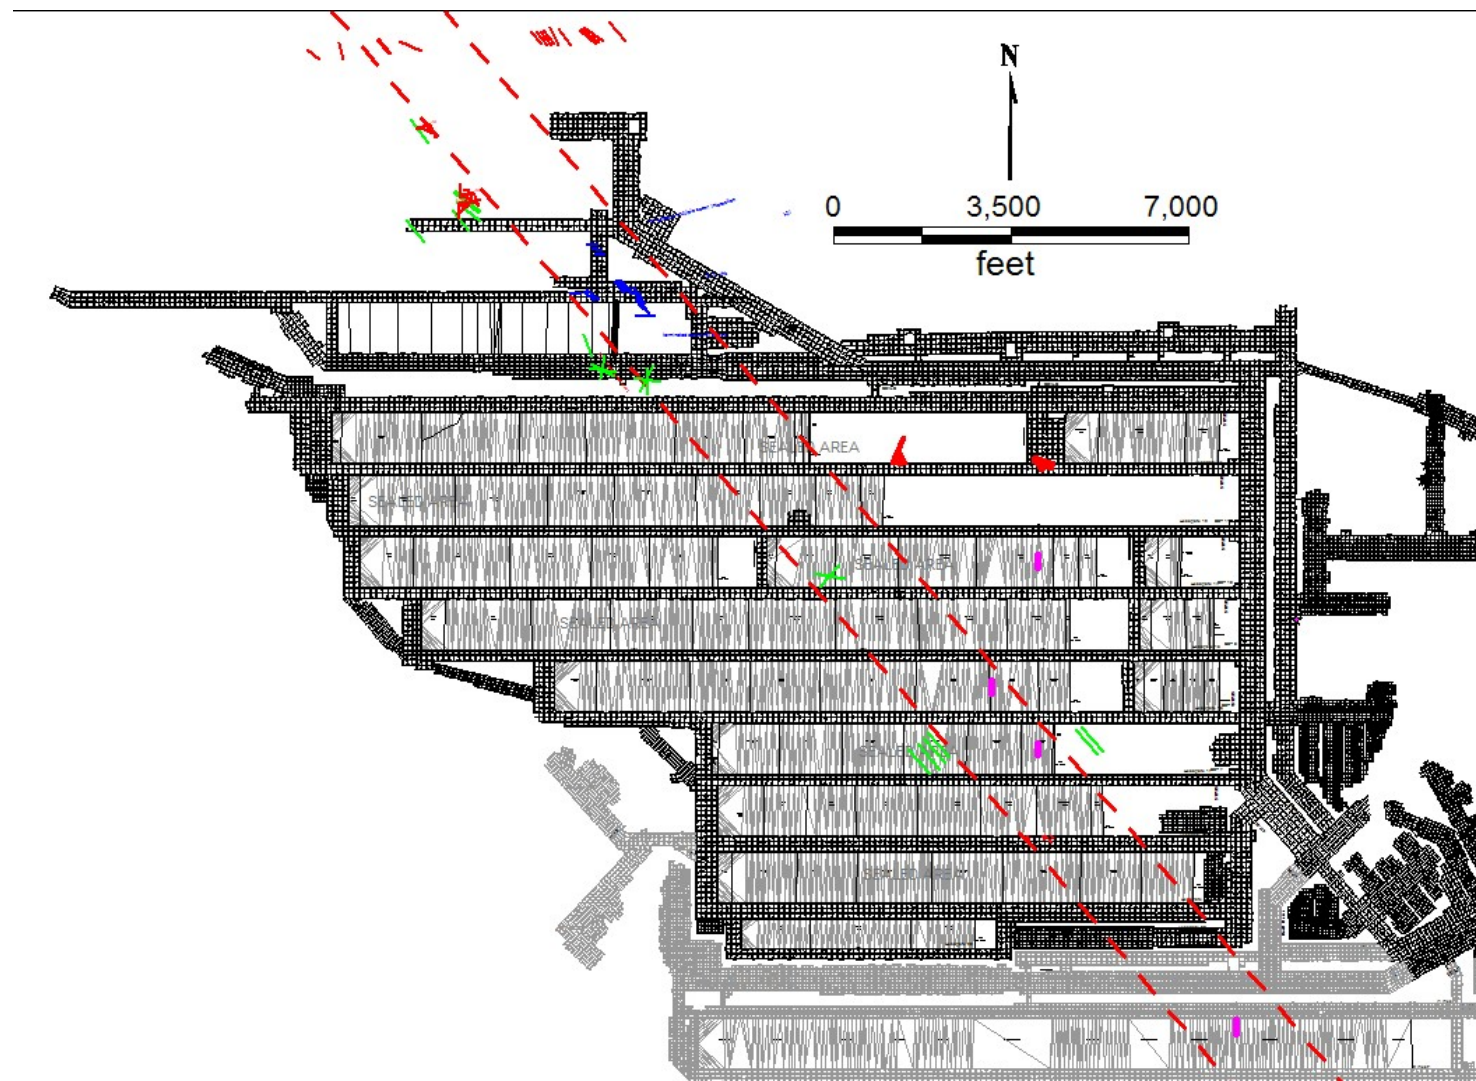
The investigation team concluded that a fault zone trends N 40° W across UBB, and dips 30° to the northeast (Figure 15). This is based on: 1) the locations of gas outbursts or explosions in 1997, 2003, and 2004, discussed above; 2) underground observations conducted at UBB in the 18 Headgate during the 2004 investigation; 3) extensive underground observations conducted between July 2010 and October 2010; 4) the face positions of Longwall Panels 11 and 12 when they were terminated; 5) observations of structural features in the overlying Powellton (Castle Mine) and Coalburg (Black Knight II Mine) seams; and 6) observations of structural features on the surface. To understand the conditions associated with the initial gas release, it is also critical to understand the interplay between the fault zone, the depth of overburden, and the redistribution of stress caused by longwall mining.

Figure 15. Upper Big Branch Mine with projected fault zone, and locations of joints (green, blue), slickensides (red), and floor burst locations (purple) used to constrain the location and trend of the fault zone.

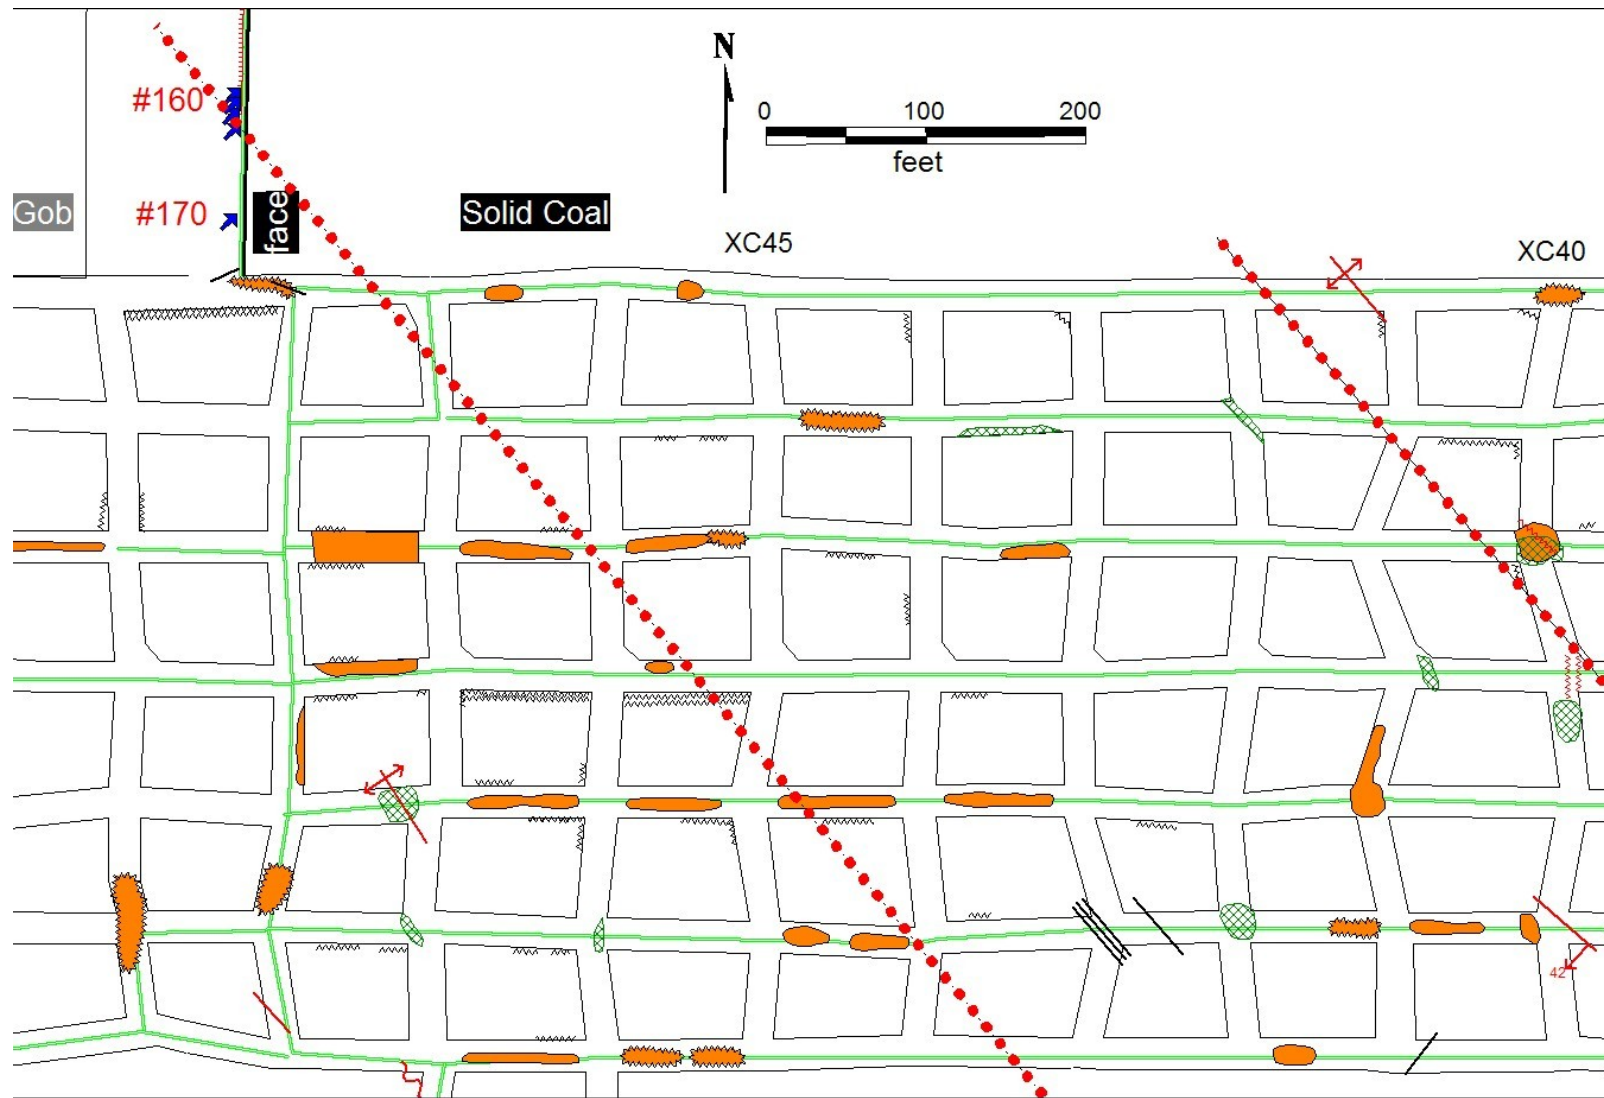
jointing, which also strike N 40° W, are present in thick sandstone layers that overlie the coal seams. The zone also localizes linear pot-outs in the roof and zones of floor heave (Figure 16).

Figure 16. Detailed mapping in Tailgate 1 North, showing trend of floor heave (orange), joints (heavy black lines), pot-outs (green hatch), rib sloughing (jagged lines), and slickensides (red lines) projecting into the longwall shield 160-171 gas feeder zone. Heavy red, dashed lines indicate individual fault zone projections. Blue arrow symbols represent floor feeders in by longwall face.

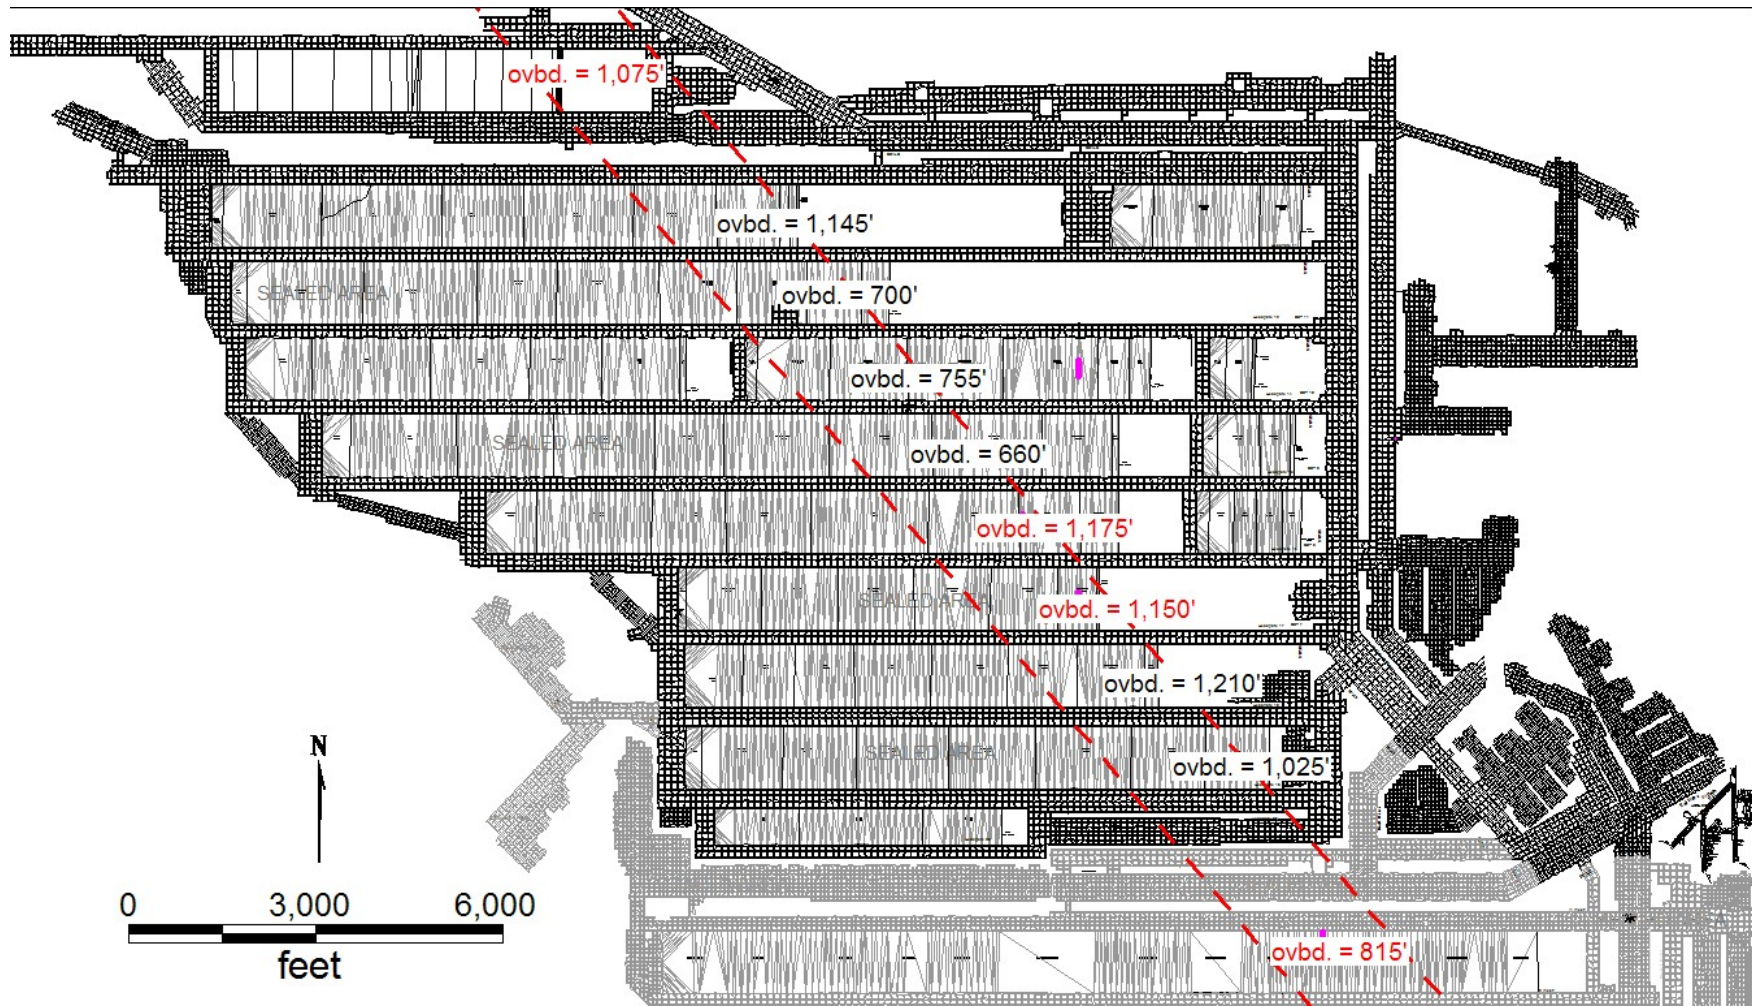
Another factor (discussed further below) in the release of methane appears to be the overburden present above the fault zone. While other panels mined through the fault zone without experiencing a methane outburst, those panels encountered overburden depths much less than 1,000 feet within the fault zone. The panels that experienced methane outbursts encountered overburden values of over 1,150 feet. It appears that several longwall panels, including Longwall Panels 11, 12, and 18 and Longwall Panels 16 and 17, were terminated in the vicinity where the projection of the fault zone intersected the 2,000-foot topographic contour. This corresponds to between 1,125 and 1,200 feet of overburden, depending on seam elevation (Figure 17).

Figure 17. Panels in which outbursts or explosions occurred are highlighted in red and lie along projected fault zone. Several panels were terminated upon intersecting the fault zone. Panels that encountered overburden of only 660-755 feet appear to have crossed the fault zone without incident, suggesting a critical overburden depth of 1,150 feet related to stress.

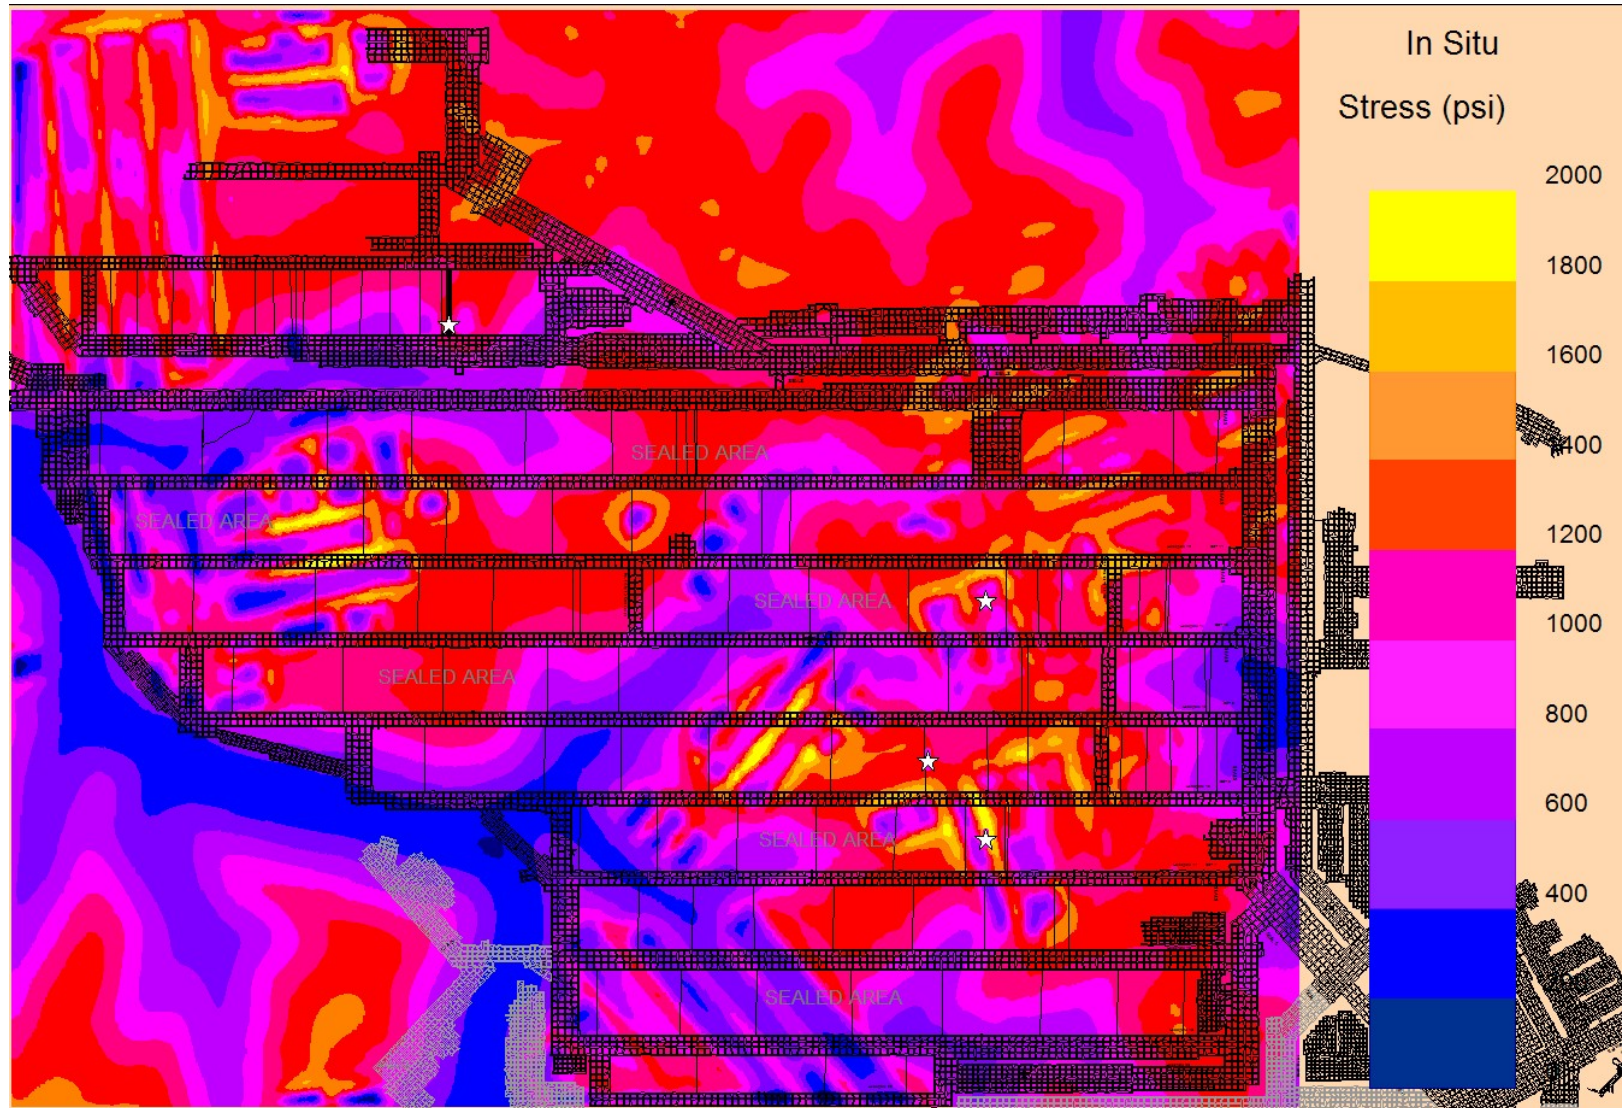
Dr. Heasley's model was used to assess the in-situ (in place) stress on the Eagle seam prior to mining to identify any high-stress areas and to assess any correlation between high stress areas and floor gas outbursts. Figure 18 represents a map of in-situ stress on the Eagle seam, including the vertical stress derived from the weight of overlying rock combined with stress associated with multiple seam interaction with the overlying Powellton seam mining. Although there appears to be a loose correlation between in-situ stress exceeding 1,200 pounds per square inch (psi) and the locations of the 2003 and 2004 gas feeder events, they are not associated with the highest stress values of 1,800 psi or greater.

At the time of the April 5 explosion, the longwall face was beneath a narrow swath of greater-than-1,200 psi stress associated with two rows of remnant pillars flanked by gob or thin, split pillars. Therefore, the documented outburst locations do not correspond to the highest stresses (>1,800 psi), and therefore, do not appear to be entirely stress-driven.

Figure 18. Map of in-situ stress on the Eagle seam, incorporating stress attributable to overburden and multiple seam interactions with the Powellton seam. White stars indicate locations of gas outbursts, with heavy black line on 1 North Panel (label), representing April 5, 2010 face position. Bright yellow patches represent >1,800 psi, with subsequent colors spaced at 200 psi intervals.

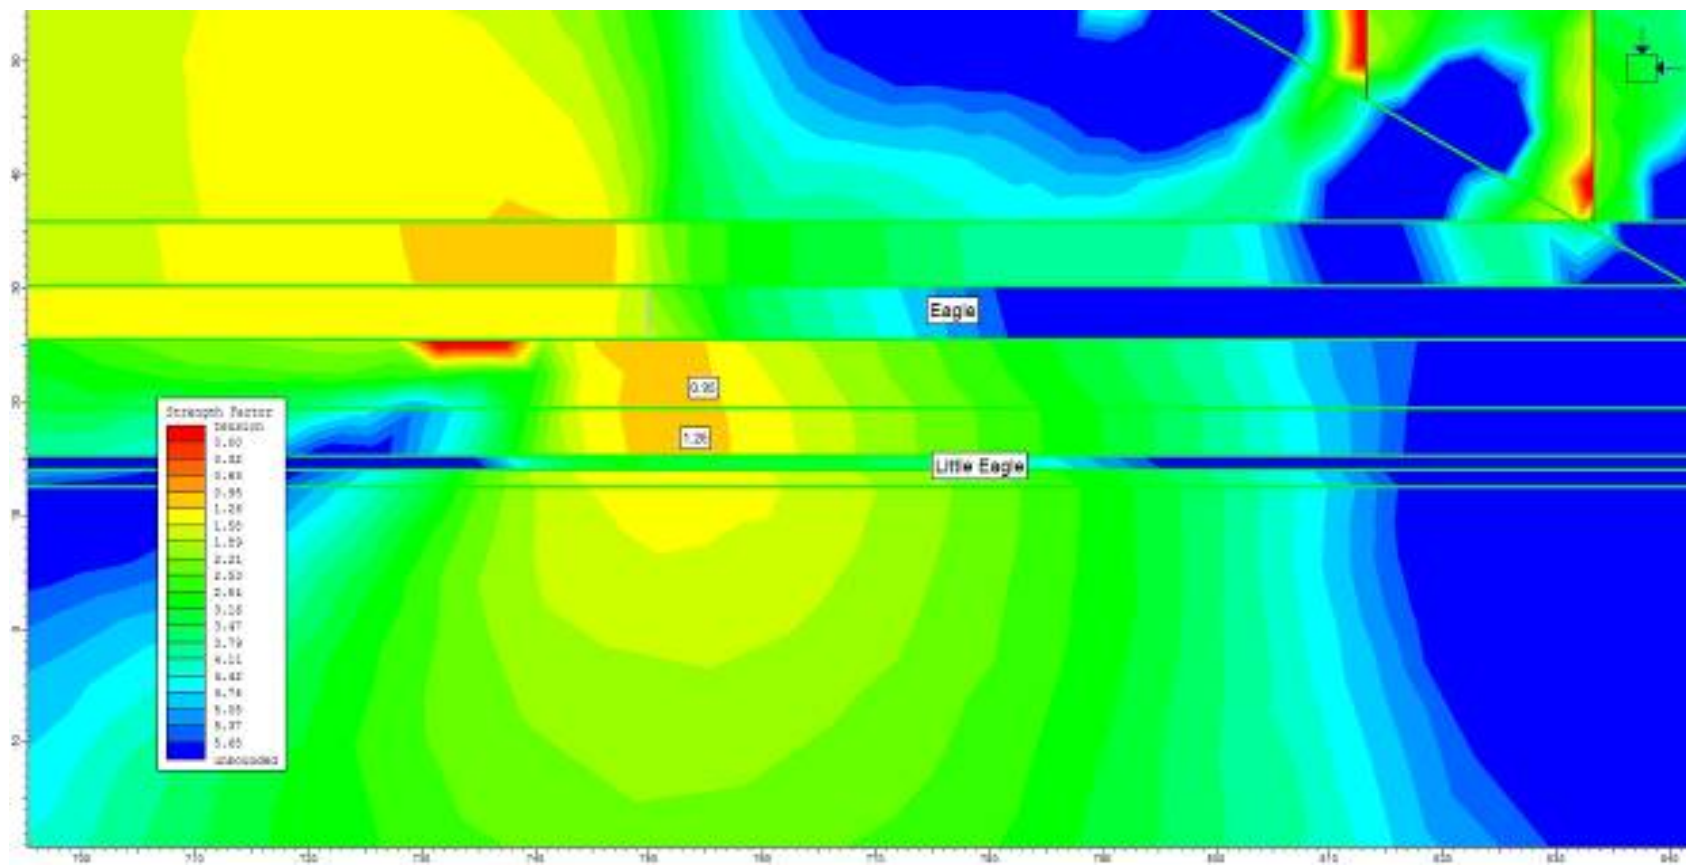
Areas outside the fault zone did not incorporate joints, and when the simulated longwall face position was 250 feet in by the April 5, 2010 position, strength factors less than one extend only a calculated five feet into the floor, approximately halfway to the Little Eagle seam (Figure 20 and 21). When the longwall face had reached its April 5, 2010 position, such that the 30°- dipping fault zone was cantilevered over the face, zones of tension extend a predicted 25 feet into the floor along joint zones, and a zone of strength factors less than one extends 15 feet into the floor. This fully encompasses the Little Eagle seam and intervening interburden to the Eagle seam, with the zone extending beneath the Little Eagle seam for a short depth.

Figure 20. Distribution of strength factors when 1 North Panel longwall face is 250 feet inby the April 5, 2010 face position, outside the projected fault zone. Strength factors less than one are calculated to extend only five feet into the floor beneath the face.

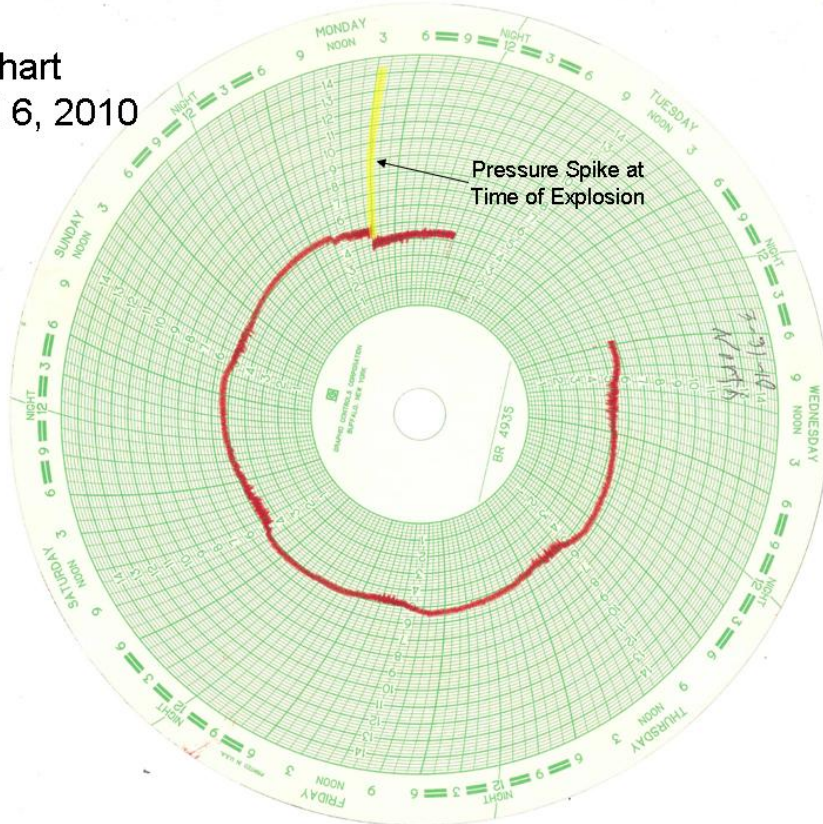
UBB was ventilated with two blowing fans and one exhausting main mine fan. The North Portal blowing fan was a Joy, Model Number 12065D, Serial No. MF4110, ten-foot axial vane fan. The fan was operated with a 1,000-horsepower, 4160 volt, 900 revolutions per minute (rpm) motor. Figure 24 is a copy of the North fan chart which was on the fan pressure recorder when the explosion occurred and shows the fan was operating at about 4.8 inches of water gauge (in. w.g.).

Figure 24. Chart for North Fan, showing pressure spike at time of explosion.

Although the fan charts shown in Figures 24 to 26 were not aligned correctly on the pressure recorder to correspond with actual time, each fan chart shows the pressure spike from the explosion. The North fan recorded a spike of over 9 in. w.g. over its normal pressure of 4.8 in. w.g. The South fan recorded a spike of 2 in. w.g. over its normal pressure of 1.4 in. w.g. The Bandytown fan spike went downward off the chart because this fan was exhausting and the pressure spike was positive. The magnitude of the spike cannot be determined but it was greater than the fan operating pressure. Several small variations in fan pressure were noted on the Bandytown fan chart following the explosion, although persons who were underground during that time reported no additional explosions.

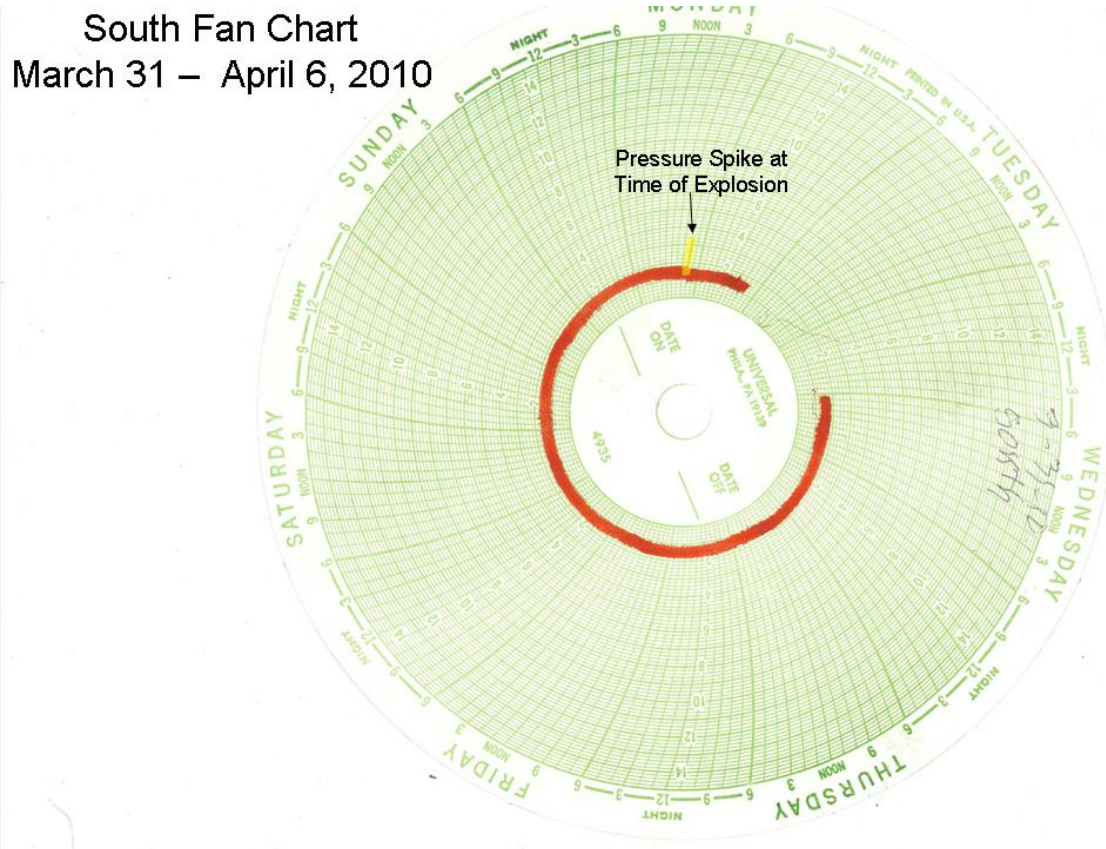
The South Portal blowing fan was an Industrial Welding Buffalo, six-foot diameter axial vane fan. The fan was operated with a 200 horsepower, 480 volt, 1,200 rpm motor. Figure 25 is a copy of the South fan chart which was on the fan pressure recorder when the explosion occurred and shows the fan was operating at about 1.4 in. w.g.

Figure 25. Chart for South Fan, showing pressure spike at time of explosion.

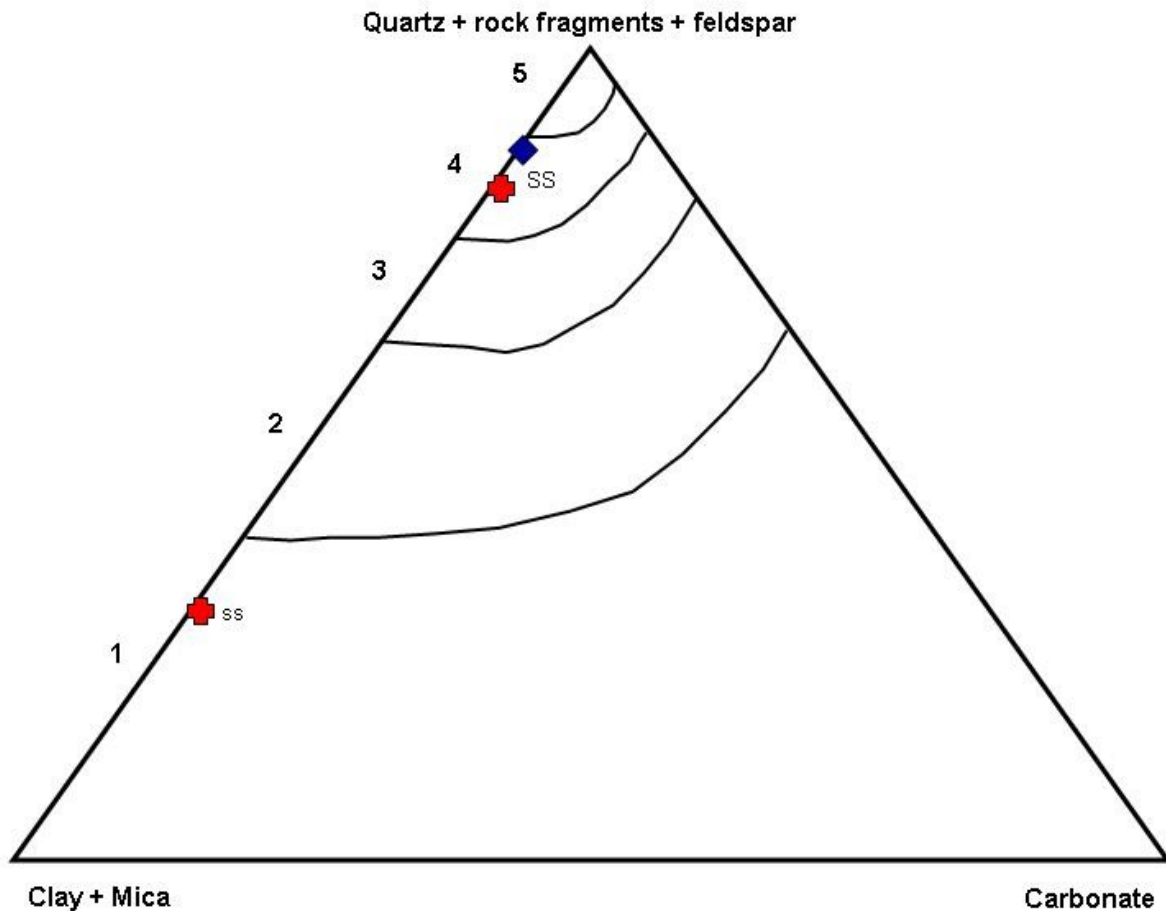
Underground observations indicated that the tail drum was cutting sandstone in the roof and floor, while the head drum was cutting sandstone in the floor. Accordingly, MSHA collected samples of the roof and floor from the tailgate side of the 1 North Panel face for petrographic analyses (Appendix Q). Based on the mineral contents determined by thin section petrography, the samples were plotted on the diagram below for comparison with the incendivity index developed for rocks in Australian coal mines (Figure 28).

The sandstone that the longwall shearer was cutting into on April 5 had a high potential for frictional ignition. The layers of coarse siltstone, which contain high mica content, plot in Category 1, indicating a low potential for frictional ignition. In contrast, the sandstone plots in Category 4 indicating a high potential for frictional ignition. The floor sandstone very nearly plots in the Category 5 zone, because of its high quartz content. Compared to the sample collected from the roof, the floor sample contains much greater quartz, and is characterized by a much greater degree of grain interlocking. Rocks with an incendivity index of 4-5 were shown in tests to have a high potential for frictional ignition, for rock-on-rock and metal-on-rock ignitions.

Figure 28. Diagram showing relation of UBB roof (red crosses) and floor (blue diamond) sandstone (SS) and siltstone (ss) to contour lines of incendivity index.

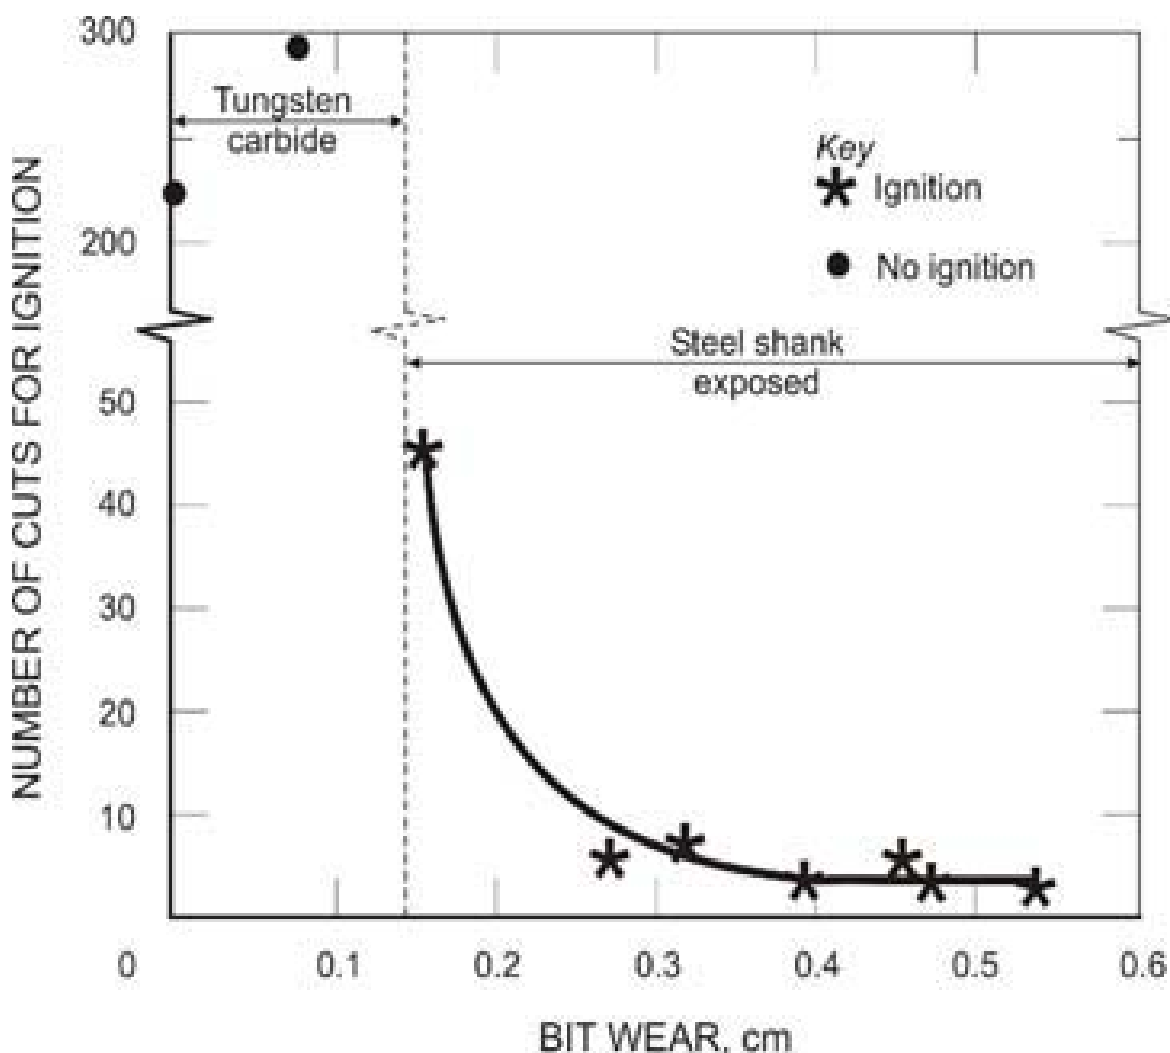
In addition, experiments have revealed that bit surface area is significantly related to the incendive potential of a hot streak. Large wear flats on the cutting bits are more likely to cause an ignition, especially when the carbide tip has worn off and as little as 3 mm of the steel shank has been abraded away (Figure 29).

Figure 29. Relation between bit wear, in centimeters, and the number of cuts required to induce a frictional ignition, from Kissell et al. (2007).
